WESTFORD

PUBLIC SAFETY FEASIBILITY STUDY

March 14, 2015

DORE & WHITTIER
ARCHITECTS, INC.

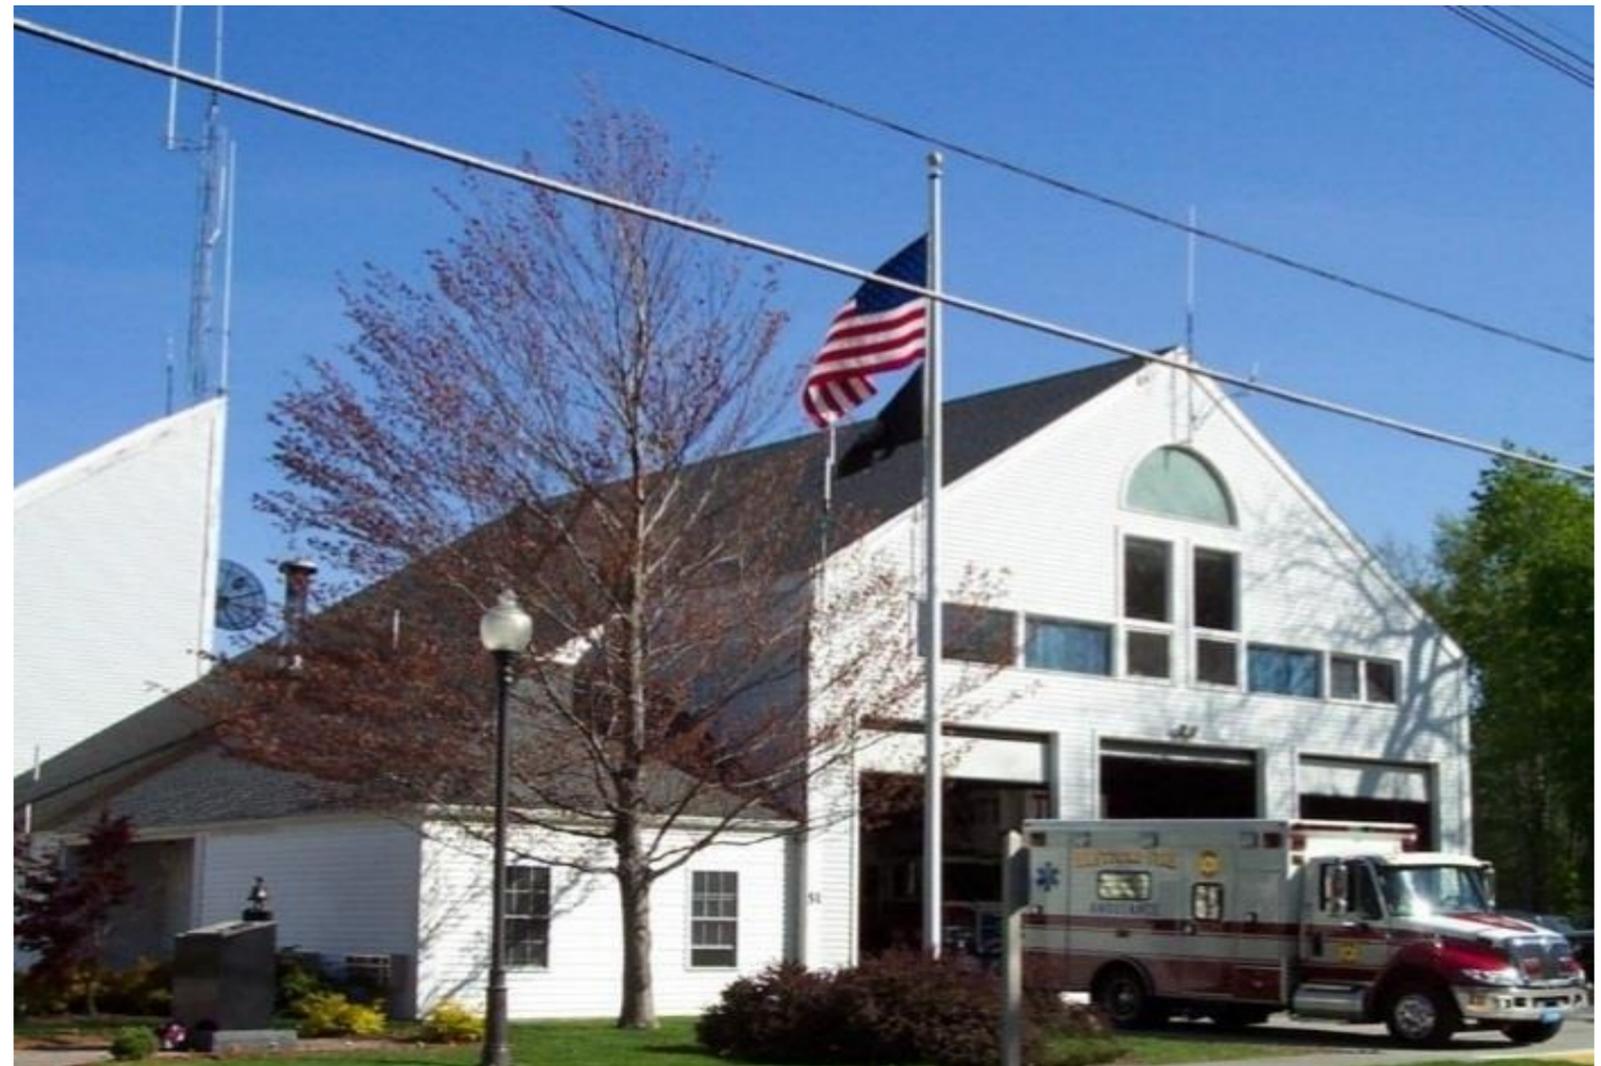
- Constructed in **1974** when Fire Department was a volunteer department, facility is inadequate to meet current or future needs of Department of Town.
- Station has three bays and stores two engines, two ambulances, and one ladder truck.
- Currently all EMS/ALS calls are dispatched from this location.
- Building needs significant upgrades to address building codes, accessibility issues, energy issues, equipment and hazardous materials storage issues.
- DRA Report dated January 29, 2014 listed many unsafe conditions of the building including unsafe egress from the second floor.
- Existing structure is approximately 30 feet tall.
- Existing usable area is approximately 6,000 sf.

- x No accommodations for full-time staff
- x No space for administrative staff
- x Building is not compliant with Americans with Disabilities Act
- x Inadequate bathroom and shower facilities for men and women
- x Inadequate sleeping quarters
- x Inadequate records storage
- x No locker room facilities
- x No area for decontamination
- x No area for bio-hazard storage
- x No space for medicine, equipment, etc. for a Paramedic Level Department with 12 paramedics
- x Unable to accommodate public meetings
- x No fire sprinkler system

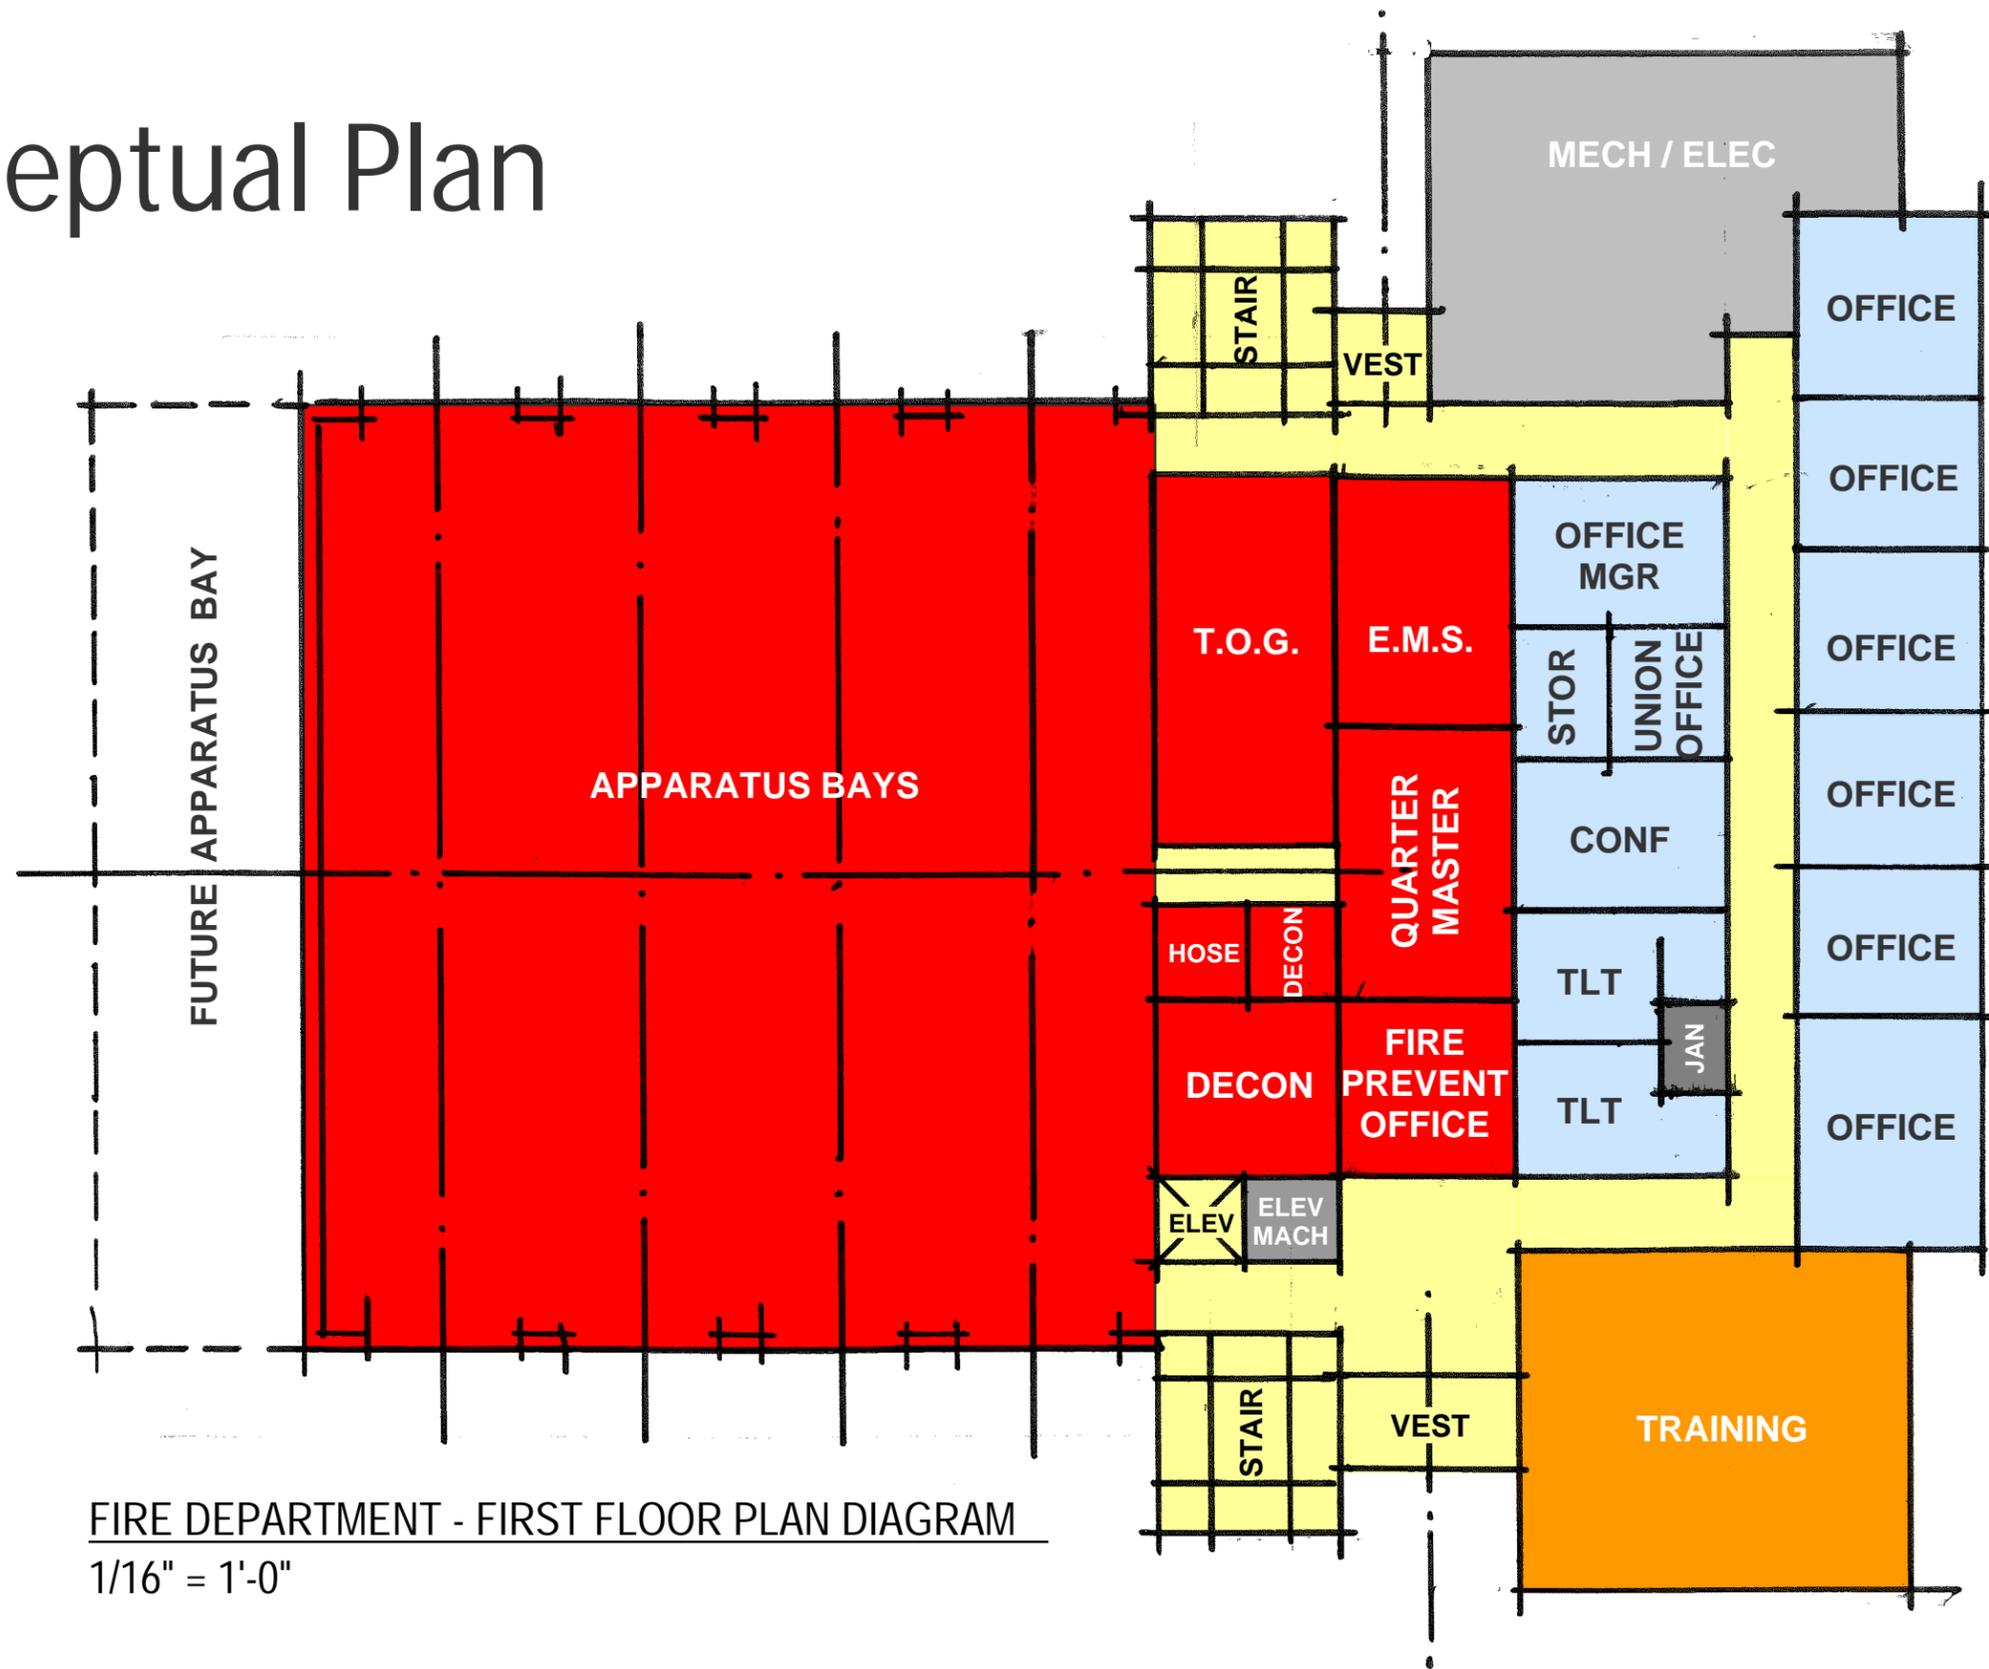
Conceptual Plan

FIRE DEPARTMENT - FIRST FLOOR PLAN DIAGRAM
1/16" = 1'-0"

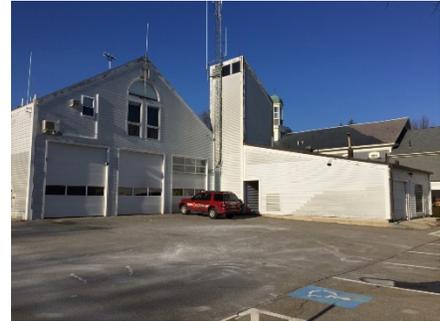
The facility needs significant upgrades to address space needs and code deficiencies, (including ADA regulations and seismic requirements), energy issues, electrical & mechanical deficiencies, lack of equipment & hazardous materials storage, and the absence of an elevator and a fire sprinkler system, as well as others that will be described in the following documentation.

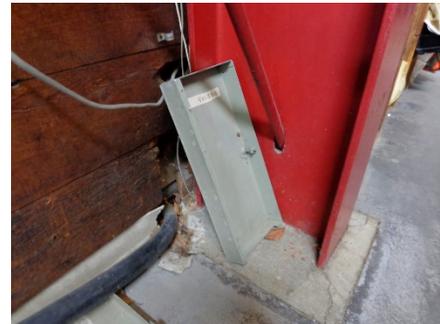
From a maintenance standpoint, the interior of the facility has been sustained to the extent feasible but numerous issues are apparent such as cracked floor slabs, degraded floor finishes, lack of insulation, water infiltration/mold issues, and underperforming mechanical and electrical systems that are beyond their useful life expectancy (building system assessments are provided in the following sections).

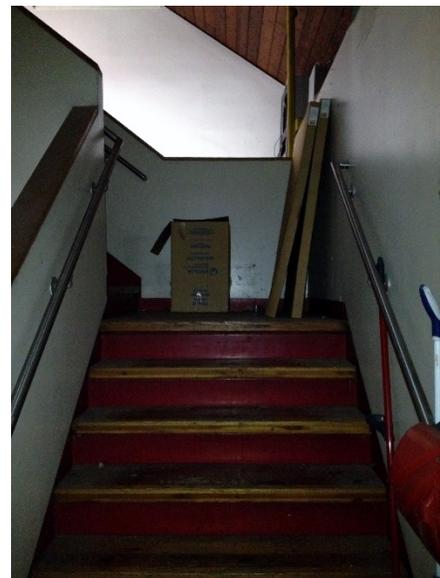
As for building codes, there are a number of life-safety issues that need to be addressed such as open stairs without guardrails; lack of emergency egress routes; exposed combustible materials such as wood ceilings; unbraced and unrated structural elements; conversion of the attic space to storage; and lack of a sprinkler system. In addition, there are numerous accessibility upgrades required to meet current ADA regulations. Specifically, an elevator needs to be added to access the second floor; several spaces have inadequate headroom; doors have insufficient clearances, hardware, and thresholds; stairs do not meet requirements for nosings and handrails; ramps need to be added to overcome differences in floor heights; kitchen sink & cabinets do not meet requirements; restroom plumbing fixtures and accessories are not compliant and restrooms do not provide adequate clearances.

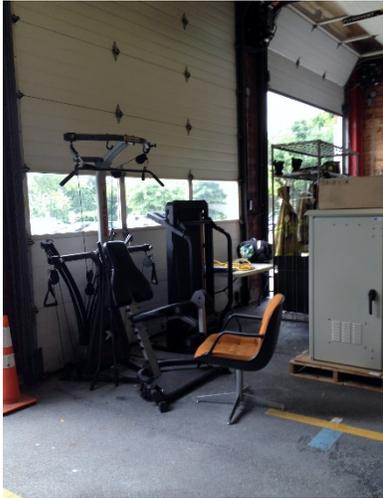
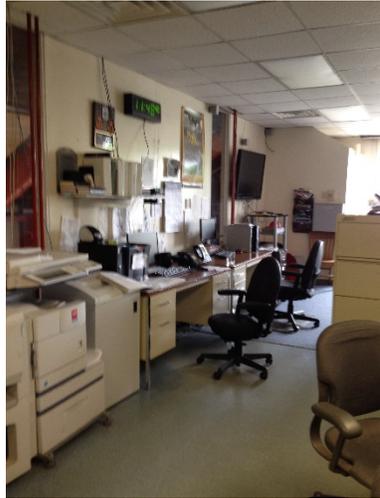
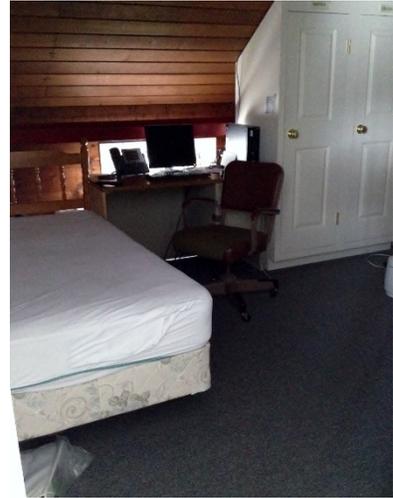
Building Exterior

Similar to the interior, the exterior of the facility has been sustained to the extent feasible but numerous issues are apparent due to weathering and initial design issues, the most significant of which is the lack of roof overhangs. As a result, the wood trim has deteriorated, allowing for water infiltration, and needs to be replaced. In addition, window glazing is inadequate and overhead doors are uninsulated, resulting in thermal issues, and the aluminum siding is in disrepair and is beyond its useful life expectancy. An evaluation of the roofing surface was not conducted as part of this study.

The existing Central Fire Station has outlived its useful life expectancy based on the growth of the department since its original construction. Due to the extent of renovations needed to resolve maintenance issues, code deficiencies, and the lack of operation space, along with the limited area available for expansion at the Town Center due to site constraints, the recommendation would be to build a new Central Fire Station in a new location with enough space for proper site access and future expansion.

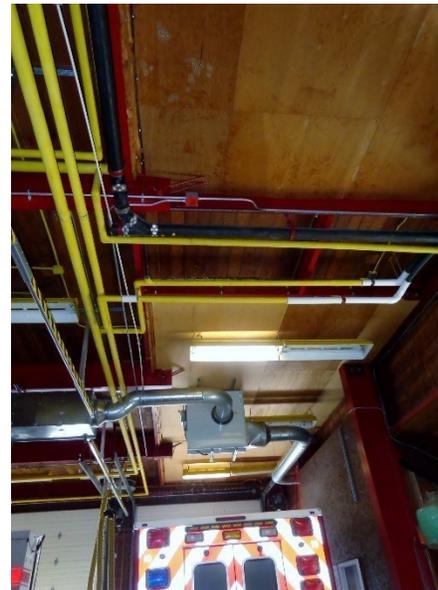
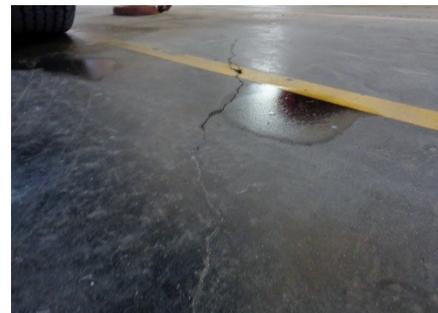
The existing structure is in sound condition and performing well for the most part. We observed moderate cracks in the concrete slab on grade, some of which radiate from central floor drains in the parking spots for the heavy vehicles. We also observed minor cracks in the drywall at the dormer located above the loft expansion. These cracks may be due to the flexibility of the structure under wind loading.

The loft expansion is performing adequately. We did not perceive any vibrations of concern due to footfall in the loft structure. We understand that the loft expansion was constructed by the staff at the fire station and may not have been engineered.

The structure is in good repair and performing well for the most part. We would recommend that the framing of the loft expansion framing be investigated to verify that it is adequately designed and supported from the original fire station structure. Further investigation may be required to view the dormer framing and determine whether any reinforcement of the structure is required. We would recommend that the cracks in the concrete slab on grade be repaired and sealed. To provide future durability, an epoxy wearing surface should be applied to the slab.

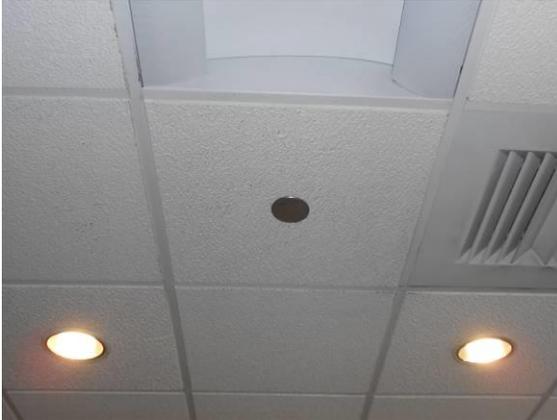
The Police Dispatch area is fully sprinklered.

Concealed Pendent Sprinkler Head

There are no recommendations at this time. The system is in good working order.

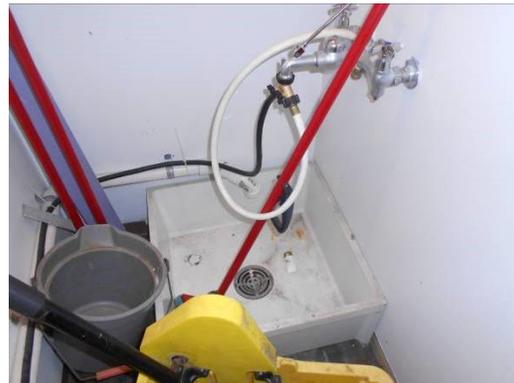
Mop Sink

Janitor's sink is a floor mounted mop receptor with wall mount faucet. Faucet is equipped with vacuum breaker.

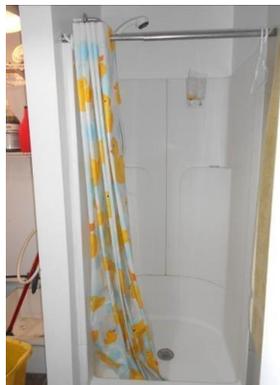
Shower

Showers are fiberglass units with single handle mixing valve and a removable hand held shower head.

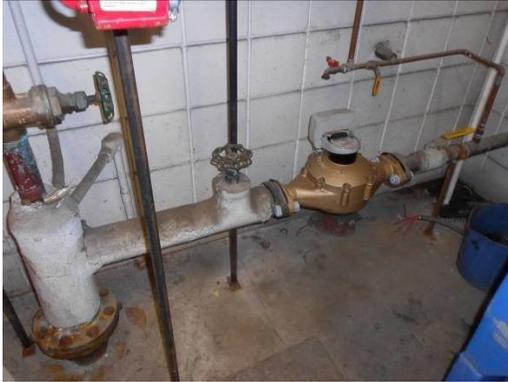
There is a reduced pressure backflow preventer for the boiler water make-up.

Domestic Water Service

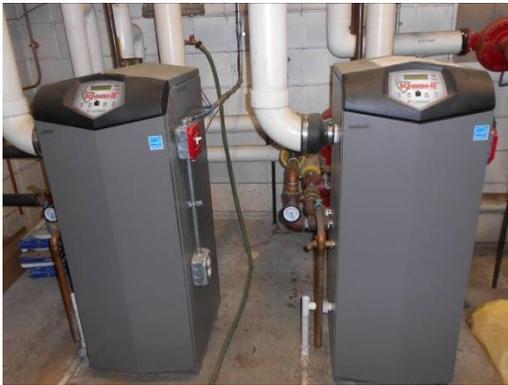
Gas Fired Condensing Boiler

The main building hot water is generated through gas fired condensing boilers and a 55 gallon hot water storage tank. The condensate from the boilers run thru a neutralization tube and spill to a floor drain. The hot water system is circulated through the building. The system does not have a mixing valve and there is no expansion tank.

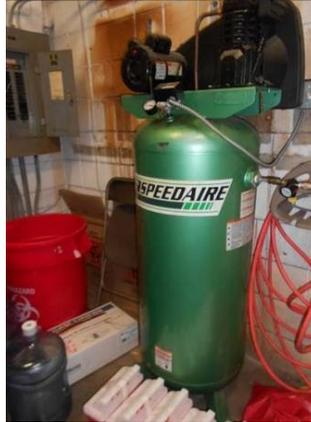
Air compressor is a SpeedAire model 4B236B with a vertical air storage tank. Compressor is in good condition.

Air Compressor

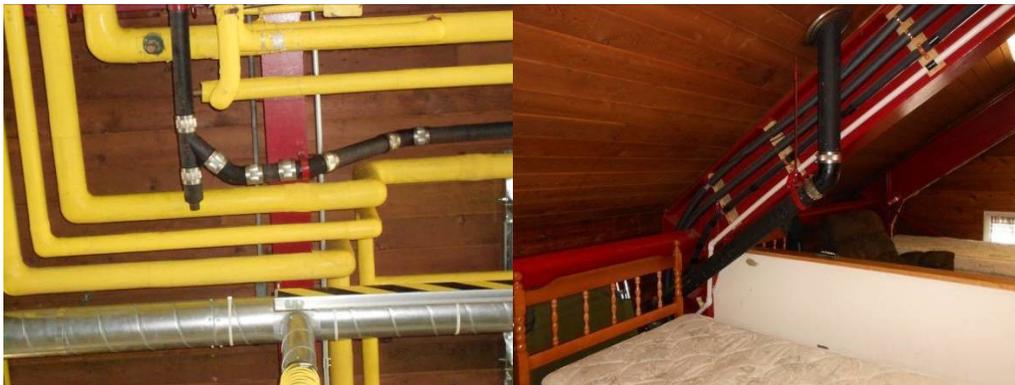
Sanitary, waste and vent piping is generally cast iron bell and spigot. Piping appears to be in good condition. There is no tight tank on site, all waste goes to sewage treatment plant.

Waste Piping

In general, existing cast iron drainage piping can be re-used if sized appropriately. We recommend video inspection of existing drains to confirm integrity.

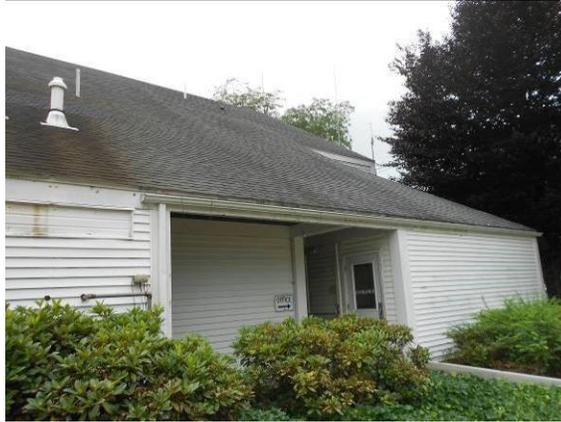
Sloped Roof with Gutter

Building has sloped roofs. Portions of roof above entry ways drains to gutters and downspouts. Downspouts discharge to grade.

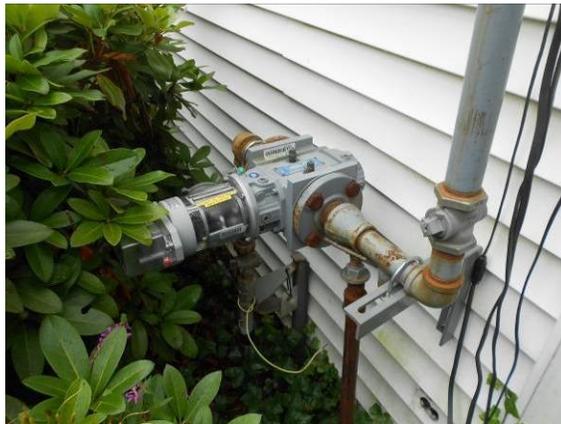
Natural gas is provided to the building. Gas service is 1 ½" in size. Gas supplies the heating boiler. In general, piping is schedule 40 black steel with threaded fittings.

Gas Meter

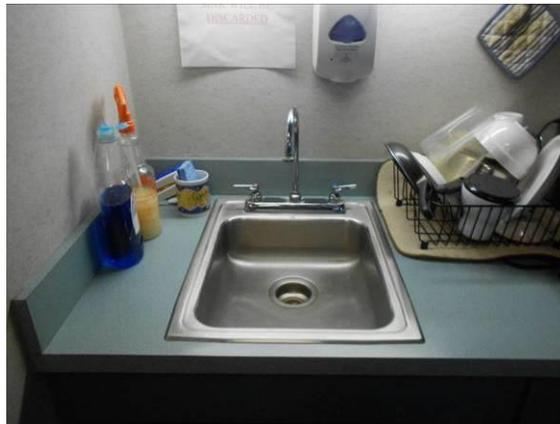
Pantry sink is single bowl counter mounted stainless steel with deck mounted faucet with hot and cold handles.

Pantry Sink

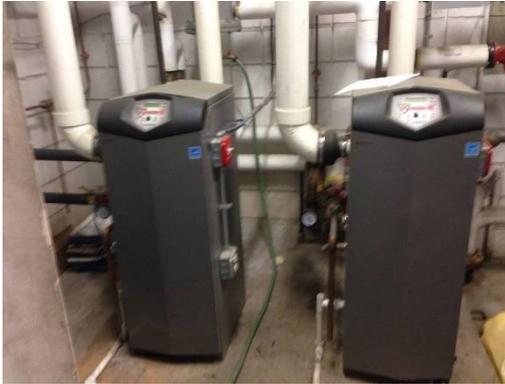
The building is primarily heated by two gas-fired high efficiency, energy star compliant, condensing hot water boilers. The boilers were manufactured by Lochinvar (Model Knight), and were installed circa 2009 according to documentation located in the boiler room. The boilers appear to be in very good physical condition.

Hot Water Boilers

Based on field observations and documentation from the Town’s Insurance Company that was located in the boiler room, the boilers do not appear to have external low water cut-off device controls. The boilers may have this control capability internally; therefore, we would recommend that the Owner confirm that the Insurance Company’s concern regarding this issue has been satisfied by providing information from the installing contractor or boiler manufacturer that these particular boiler models have a low water cutoff safety control feature. The boilers have externally mounted gas shut-off switches installed.

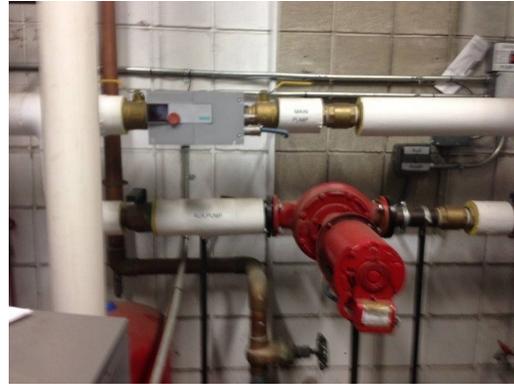
Hot Water Pumps

Hot water is distributed from the boilers to building hot water heating equipment, consisting of propeller type unit heaters, cabinet unit heaters, and an indoor air handling unit via a 2 pipe hot water piping distribution system. The hot water boilers also serve the domestic hot water heating tank for the building. There are two hot water circulator pumps located in the boiler room. The primary hot water pump, equipped with variable ECM motor, appears to be in good condition, was installed in 2009 and was manufactured by Wilo. The back-up hot water pump appears to be older in age, in fair condition and was manufactured by Bell & Gossett.

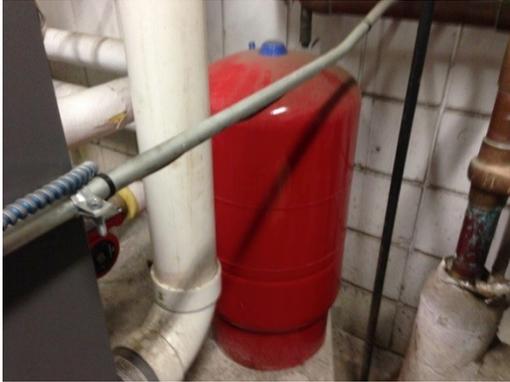
Hot Expansion Tank

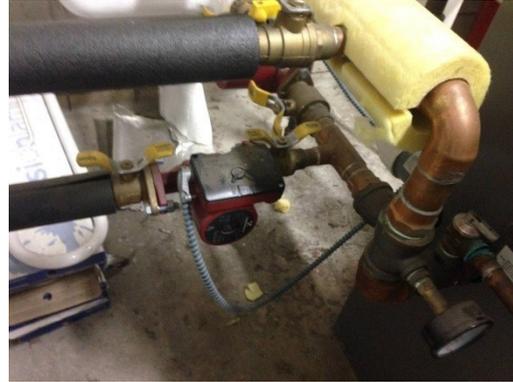
The majority of the hot water piping distribution system is insulated with fiberglass piping insulation. However some sections are missing insulation (or insulation facing jacket), or are insulated with “armor-flex” type insulation.

Missing Insulation & "Armor-flex" type Insulation on HW Piping

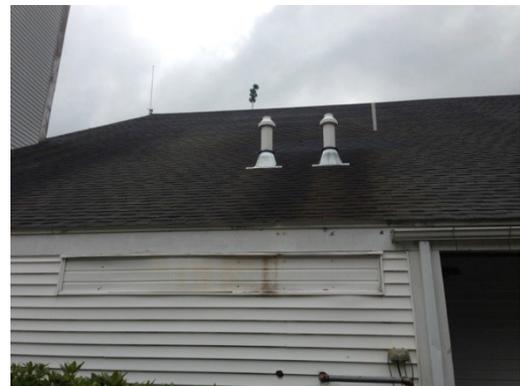
Boiler Concentric Vents

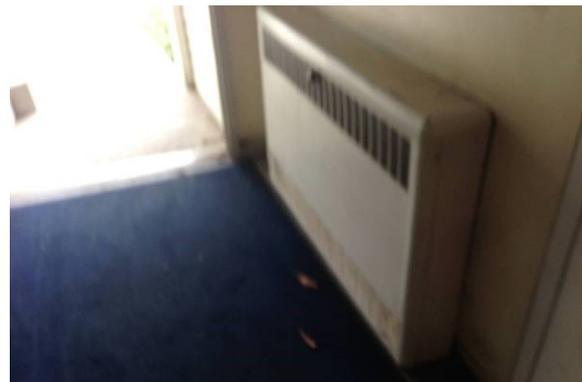
The entryway cabinet unit heaters appear to be originally installed equipment and in general appear to be in poor to fair condition.

Entryway Cabinet Unit Heater

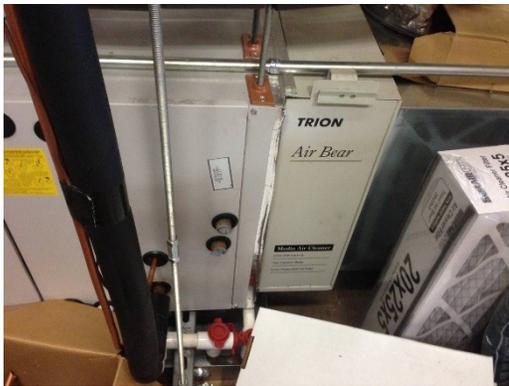
The indoor air handling unit was installed circa 2009 and was manufactured by First Co. (Model 48VH8X8-HW). The unit is piped with refrigeration piping to an associated outdoor air cooled heat pump air cooled condensing unit. The heat pump air cooled condensing unit was manufactured by Carrier (Model 24ACB348A30, 208 V/1 ph, R410A), was installed in 2009, and has a cooling capacity of 45,500 btuh. Both the air handling unit and associated air-cooled condensing unit appear to be in good condition. The air handling unit provides heating via a unit mounted hot water heating coil which is piped to the building boiler plant.

Attic Air Handling Unit

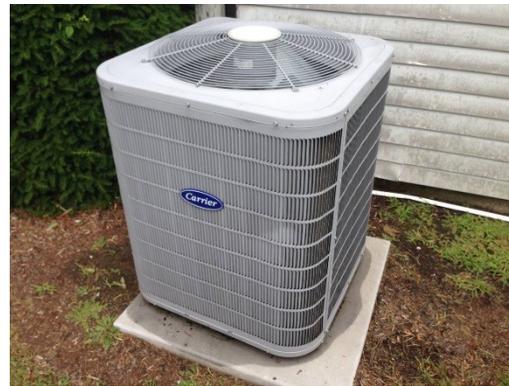
Air Cooled Condensing Unit

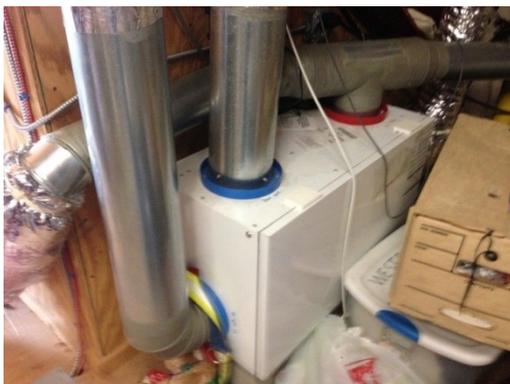
Outdoor ventilation air that is provided to the air handling unit return ductwork section is pre-conditioned by a small heating energy recovery ventilation (ERV) unit located across from the air handling unit in the Attic. The ERV unit appears to be in good condition, was manufactured by LifeBreath and was installed circa 2009.

Attic ERV Unit

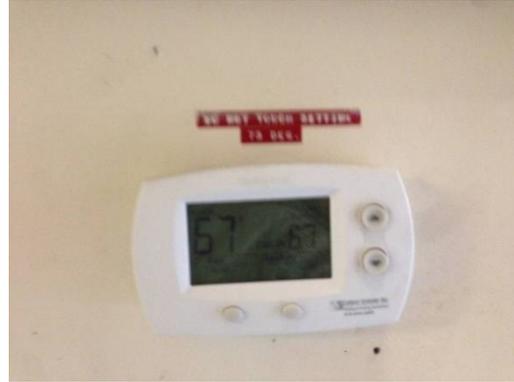
AHU Thermostat

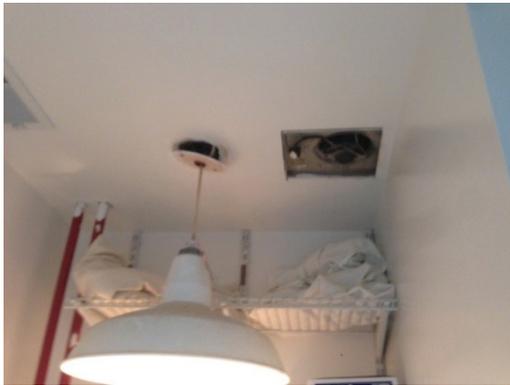
Restroom Ceiling Exhaust Fan

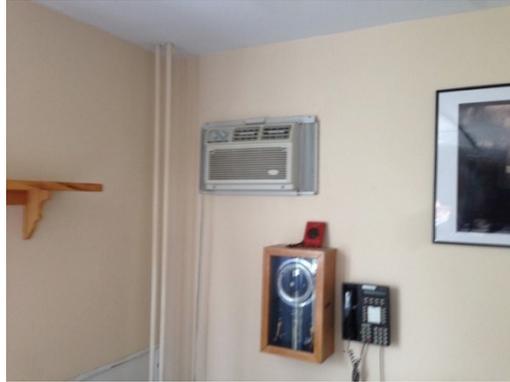
The Second Floor Chief's office and corner office are heated and air conditioned by a packaged through wall air conditioner (PTAC) unit and a window air conditioning unit that has been installed through the exterior wall of the building. Both units appear to be in fair condition. These type of AC units are very inefficient and noisy in comparison to alternative HVAC systems which are typically used in Fire Station buildings.

Window Air Conditioner Unit

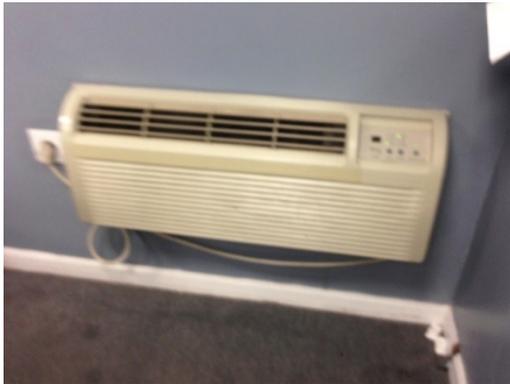
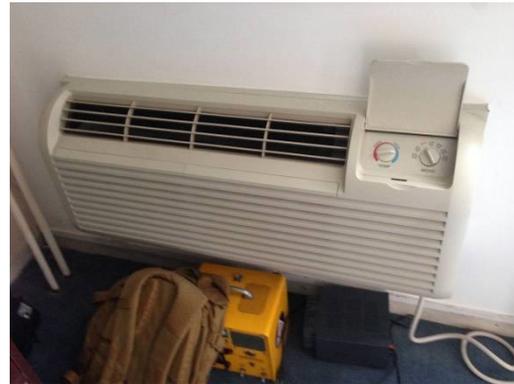
PTAC Type AC Units

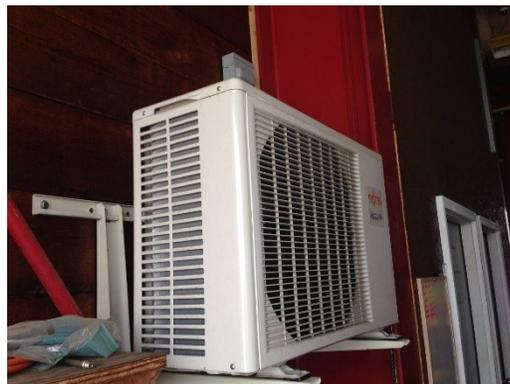
There are two (2) ductless air conditioning units with associated outdoor air cooled condensing units. One system serves an office, and the other units provide cooling for IT equipment. One of the condensing units is supported from the exterior building wall via support steel, and the other unit is installed in the Apparatus bay, supported from the exterior wall with support steel. The ductless cooling unit systems appear to be in fair to good condition.

Air Cooled Condensing Unit (in Apparatus Bay)

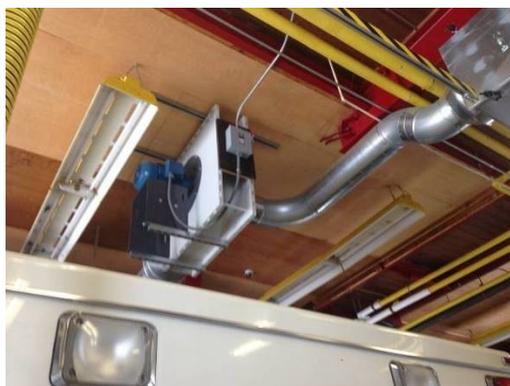
Vehicle Exhaust Fan

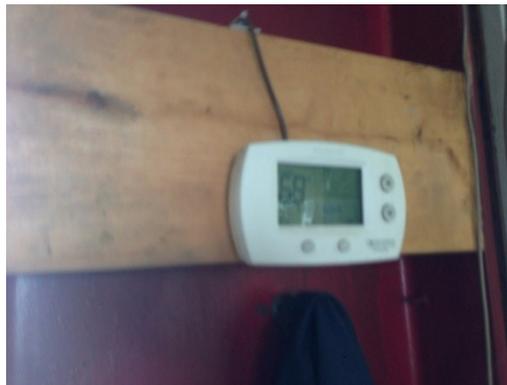
Apparatus Bay – Heating Thermostat

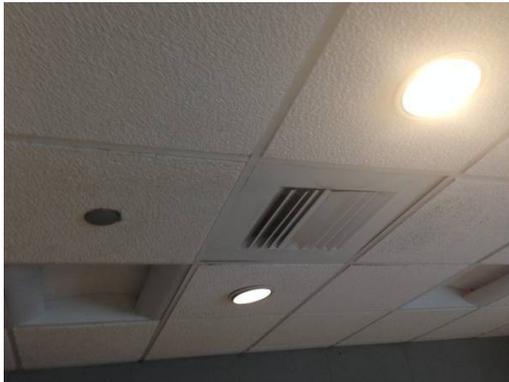
The Police Station Dispatch area is primarily heated and air conditioned by an indoor fan coil air handling unit that is located above the ACT ceiling. The air handling unit has a split system DX evaporative cooling coil which is piped with refrigeration piping to an outdoor air cooled condensing unit. Supply air ductwork is ducted from the air handling unit to ceiling mounted supply diffusers.

Dispatch Area – Supply Diffuser

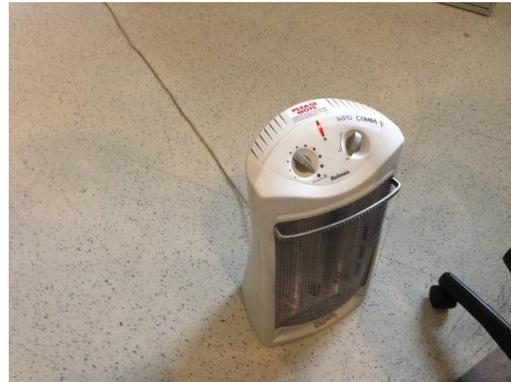
Dispatch Area – Electric Space Heater

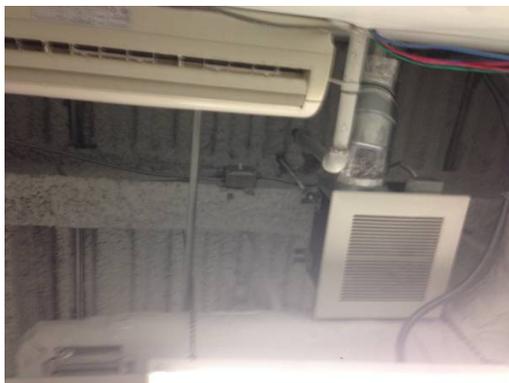
The IT server room is air conditioned by a ductless wall mounted AC unit equipped with a wireless wall mounted thermostat and wall mounted condensate pump. The unit is piped to an outdoor condensing unit. The Server room is also ventilated by a ceiling cabinet type exhaust air fan located in the room. The fan is controlled by a wall mounted switch. The AC unit and fan appear to be in good condition, and it is our understanding that the systems maintain proper temperature control in the server room.

Server Room Ductless AC Unit

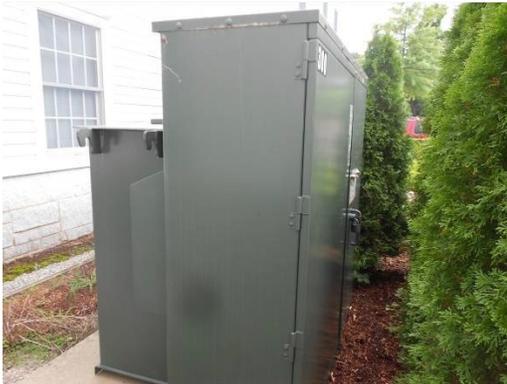
Pad Mounted Transformer

Secondary service runs underground between the pad mounted transformer and a 200 ampere, 277/480 volts, 3 phase, 4 wire main breaker panel located in the adjacent generator building.

The distribution panel feeds two 45 KVA transformers which feed two panels in the adjacent electric room. One panel is normal/emergency and the second panel is normal only.

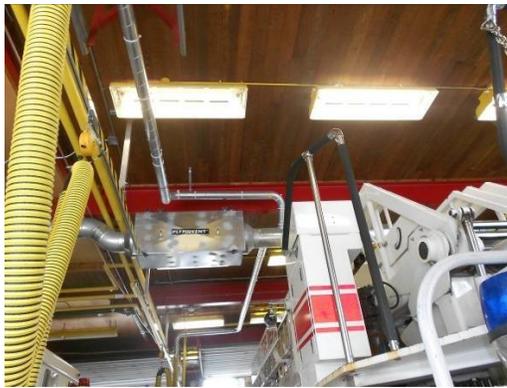
The existing lighting fixtures although retrofitted with energy efficient lamps are generally in fair condition and not the most appropriate for the space.

Apparatus Bay Lighting

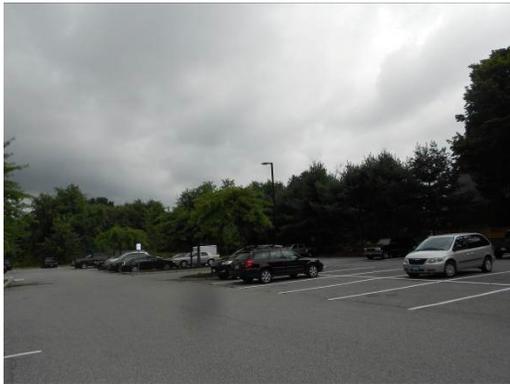
Exterior lighting is inadequate and is not dark sky compliant.

Pole Mounted Fixture

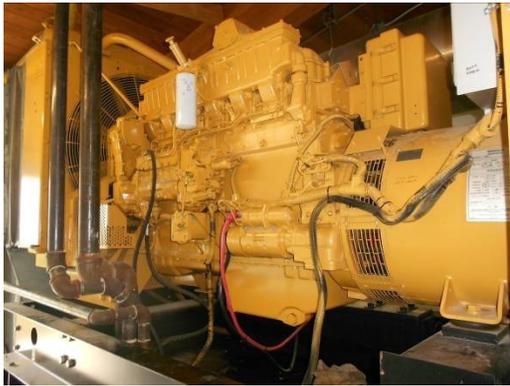
Interior Generator

The existing emergency power system does not meet current codes which require a dedicated transfer switch and panel with fire rated feeders for life safety lighting and exit signs. The emergency transfer switches and panels for life safety are required to be housed in a dedicated fire rated room.

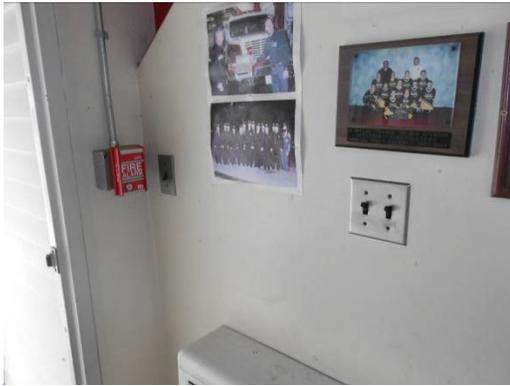
Pull Station

The fire alarm system is obsolete, offers inadequate coverage, and does not meet code. The system should be replaced.

The fire alarm system should be replaced with an addressable, ADA compliant system with full coverage.

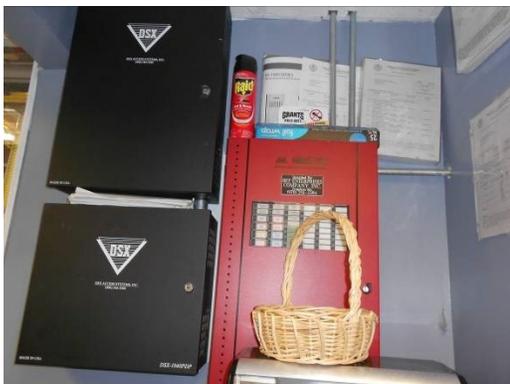
Fire Alarm Control Panel

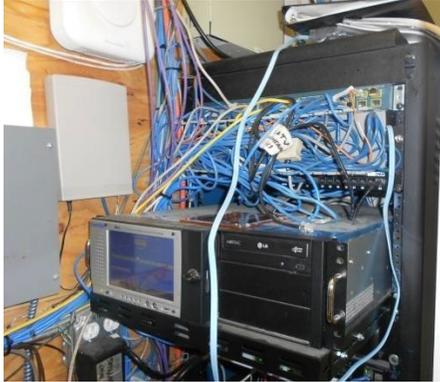
Communication Rack

The communication tel/data rack is located in the closet off of the Dispatch room. Wall fixtures are located throughout the building. A tri-pole antenna tower exists at the rear of building.

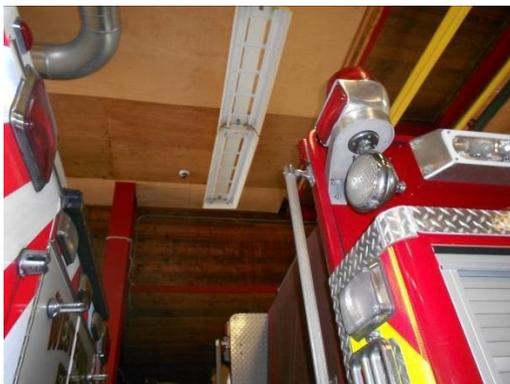
Apparatus Bay Camera

The facility has a closed circuit TV system. Wall mounted cameras are located in the apparatus bay, vestibule and exterior of the building.

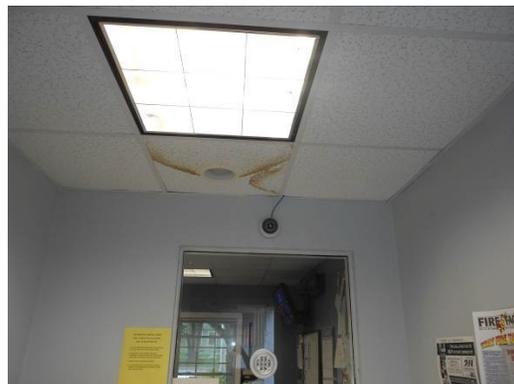
Vestibule Camera

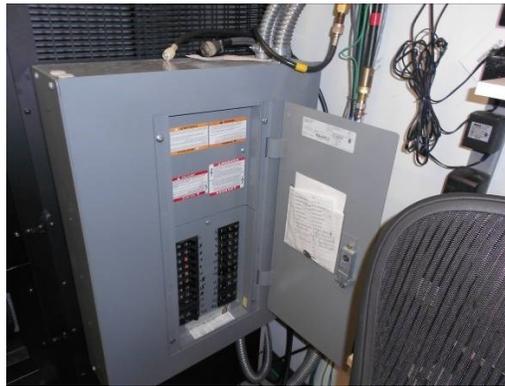
The electrical panel is located directly in front of the E-911 UPS and is in violation of code.

Panel

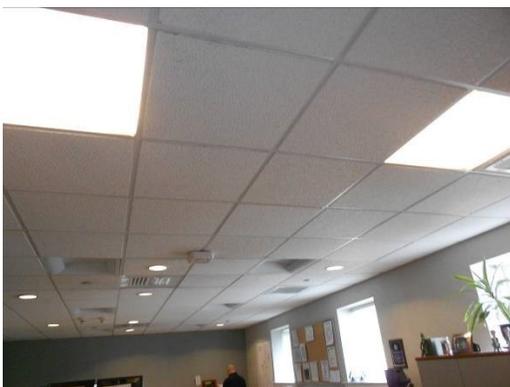
General interior lighting is in good condition.

2x2 Recessed Fixtures

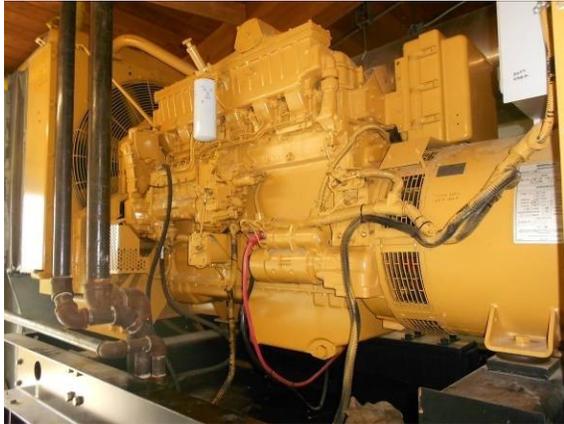
The emergency power generator consists of a 300 KW, 375 KVA, 277/480 volts, 3 phase, 4 wire. The interior generator is located in a separate building and is shared with the Town Hall and Fire Department. A remote annunciator is located in Dispatch. The generator is manufactured by Caterpillar and is in good condition.

Generator

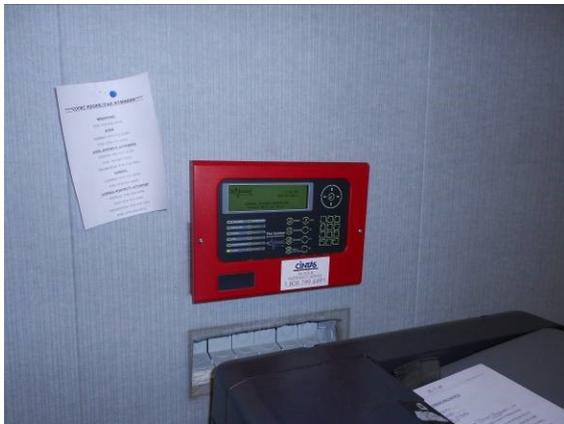
Remote Annunciator

The fire alarm system consists of a remote annunciator and smoke detectors in the dispatch room.

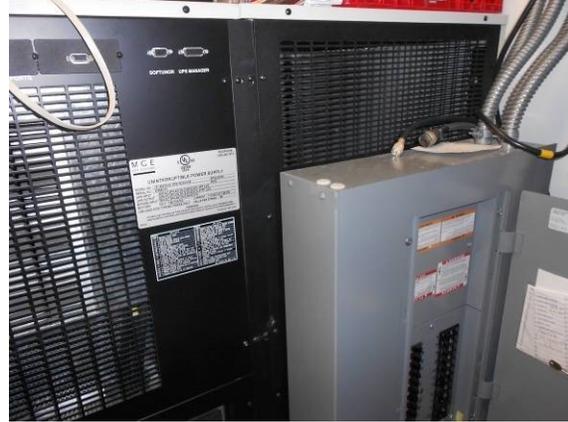
UPS System

The E-911 UPS, Uninterruptible Power Supply, Emergency electric panel, and the emergency communications rack are located in the Communication Room.

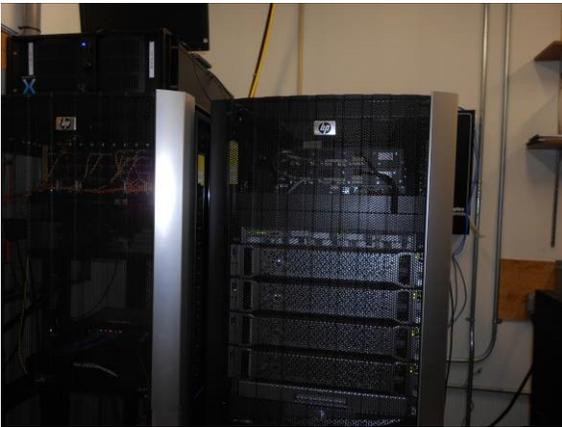
Data Rack

The tel/data rack is also located in the Communication Room.

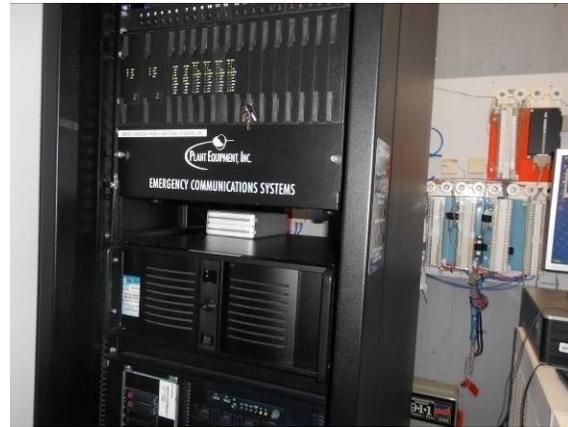
Emergency Communications Rack

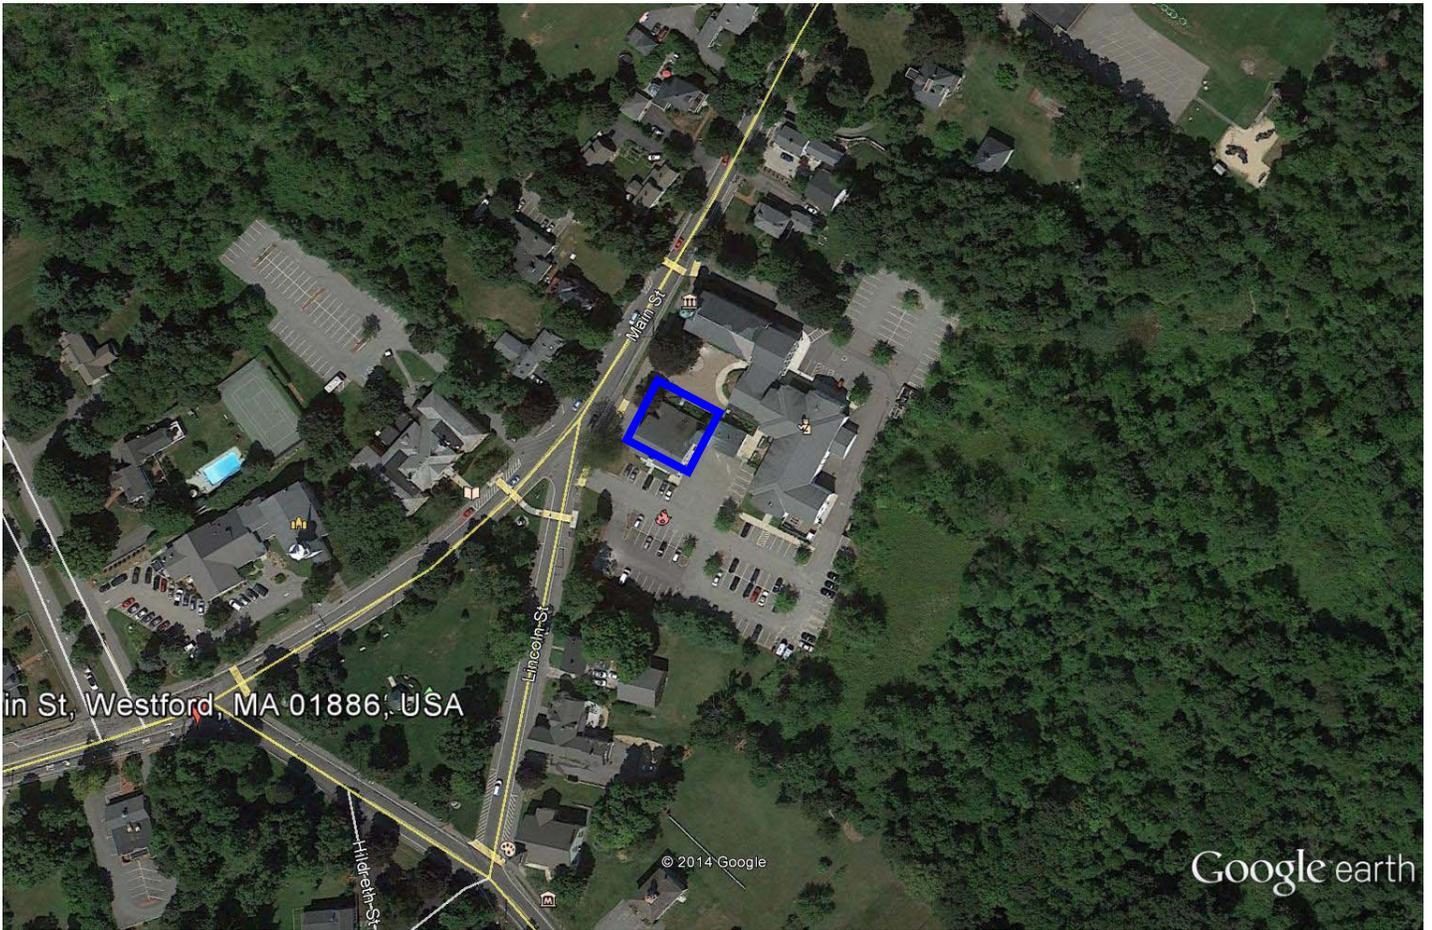
FIGURE 3: SITE PLAN

LAI was accompanied by Lieutenant Shawn Girard, with the Westford Fire Department during the inspection. A Site Plan depicting significant features observed is included as **Figure 3** and photographs are included in **Appendix A** of this report.

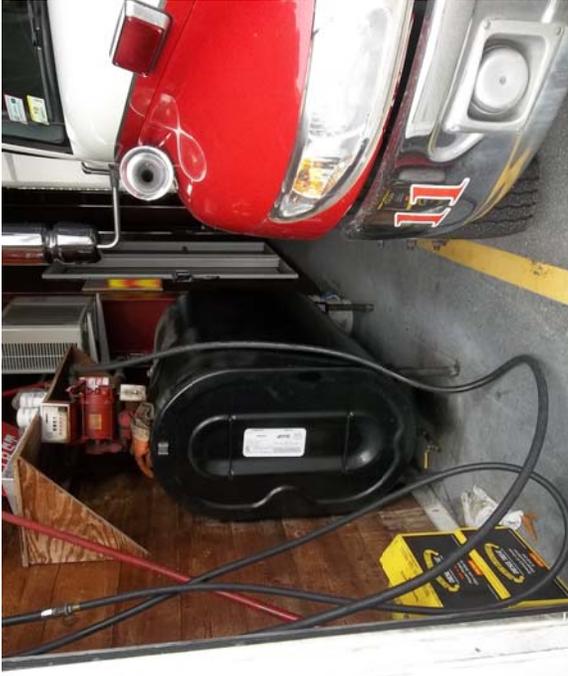
Photo #5: 275-gallon diesel AST for fueling the fire vehicles

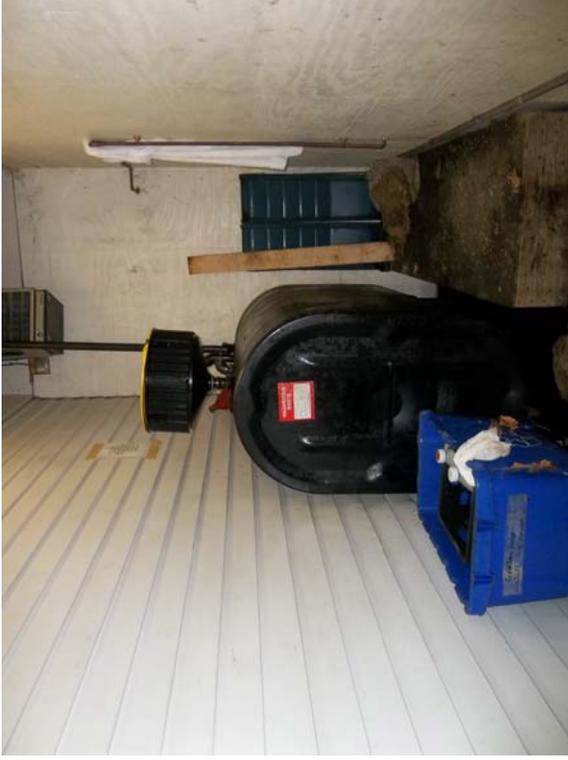
Photo #6: 275-gallon waste oil tank
